AN INTEGRATED MODEL SIMULATING THE INITIATION AND MOTION OF EARTHQUAKE AND RAIN INDUCED LANDSLIDE IN PAKISTAN

UNESCO-JASTIP Joint Symposium on Intra-Regional Water Security and Disaster Management

An integrated model simulating the initiation and motion of earthquake and rain induced landslide in Pakistan

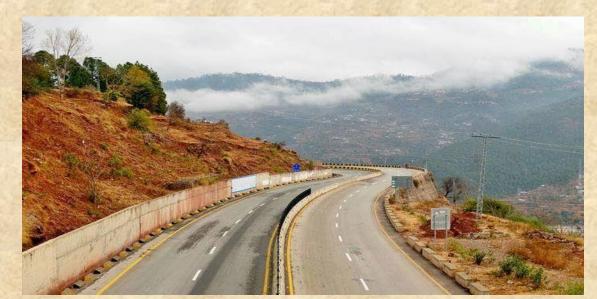
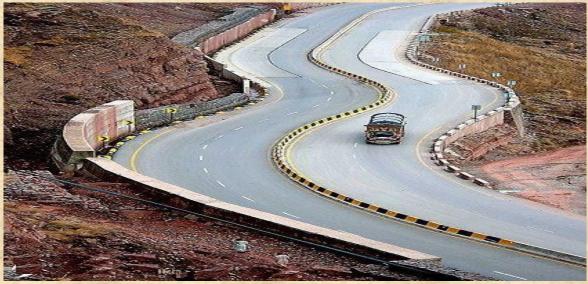
RCC Retaining Walls along Muzaffarabad-Islamabad Highway

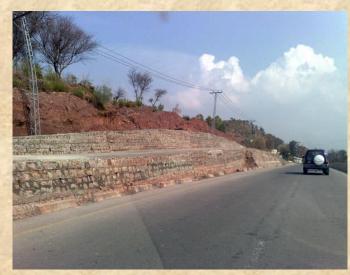
Stone Masonry Retaining Walls
